Vibration Analysis fixes Unbalanced Motor

A power generation plant in TX was experiencing repeated shutdowns from high vibration alarms. The vibration data on the fan pointed to unbalance as the problem.

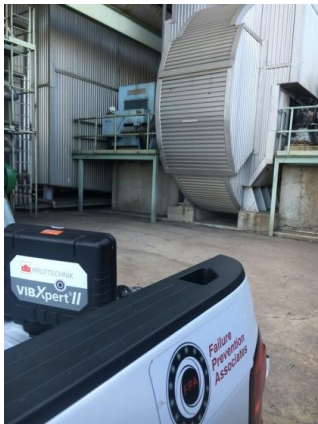
We learned the fan had been out of service for several years due to the high vibration trips. Auxiliary fans have been used to allow production to continue. While the balancing job looked good, no changes meant we needed to look elsewhere. The staff related that full capacity power generation was not being achieved using these alternative methods.

The fan has sleeve bearings. So it must be run on a turning gear to protect the bearings and the shaft when not running. The power company is burning extra power to keep this asset “available” without receiving any production value from it.

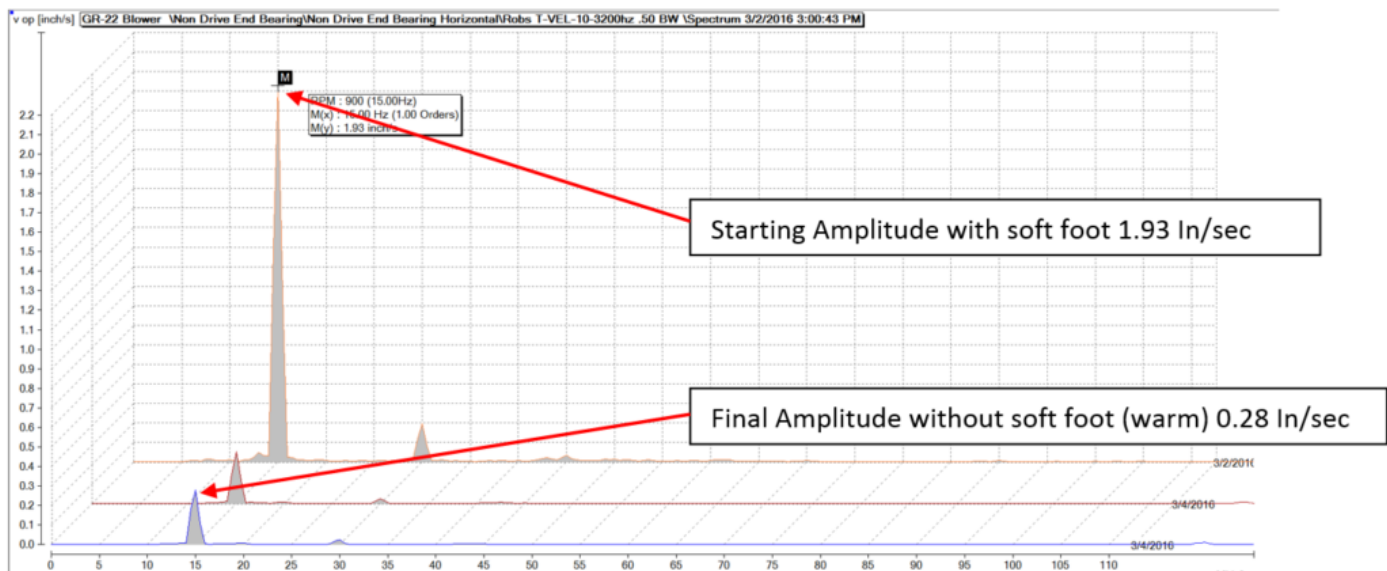
Each motor foot hold down nut was loosened; the movement of the foot was measured by a dial indicator. Three (3) of the four feet moved 3 one-thousandths of an inch. The right rear foot was found to move ten (10) one-thousandths. A significant difference. Shims were placed under the foot to resolve the 10 mil deficit.

The motor was energized and run for 45 minutes. Pre-and post-mitigation vibration signatures were obtained. The graph below illustrates the dramatic 700% loss of vibration energy due removal of the soft foot condition.
